NESQUEHONING 4TH HOLLOW RESERVOIR

NDI NO. PA-00806
DER NO. 13-104

**PHASE I INSPECTION REPORT
NATIONAL DAM INSPECTION PROGRAM**

Berger Associates, Inc.
Harrisburg, Pennsylvania

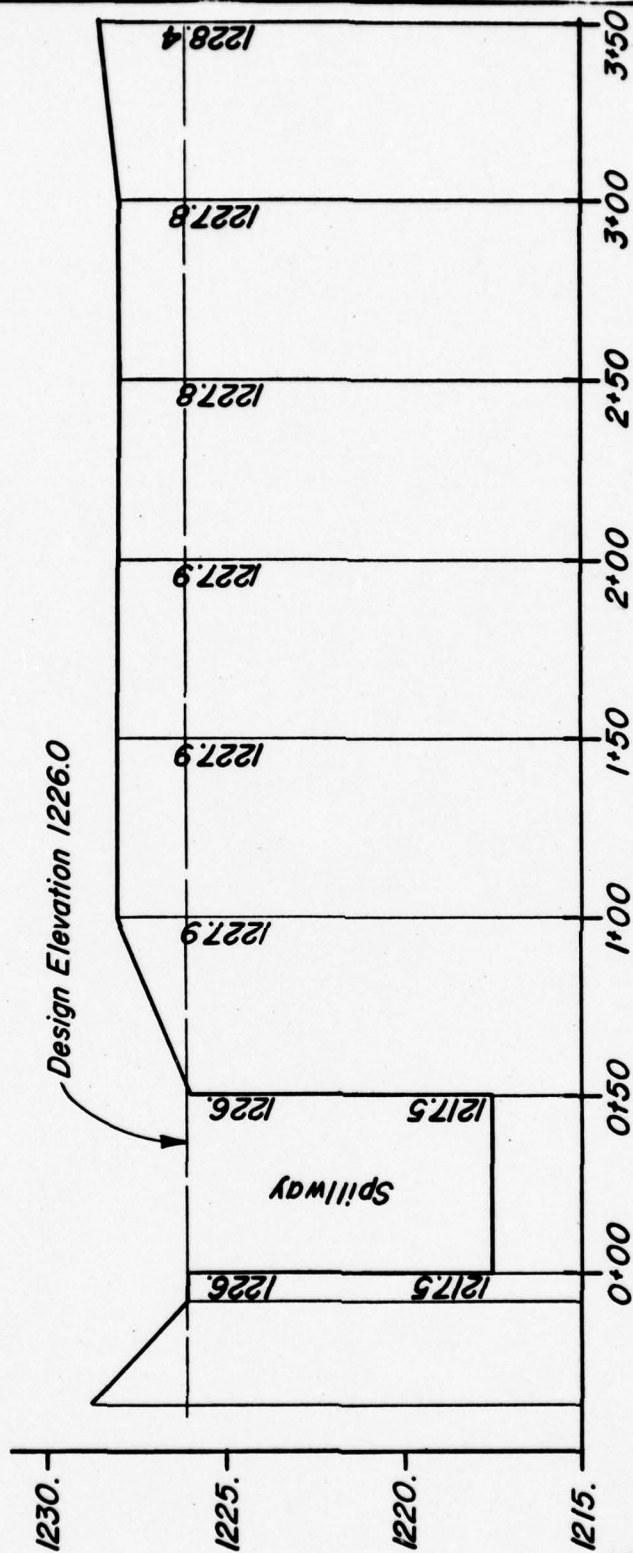
NESQUEHONING 4th
HOLLOW RESERVOIR
DAM
PA-806
INSPECTION SURVEY
PLATE A-II

The upstream slope was in excellent condition and well protected with heavy riprap. The breast of the dam was level and above the spillway walls (Plate A-II, Appendix A), and covered with gravel. The downstream slope has little or no vegetation in several places, mainly caused by trail bikes. The Borough has installed several fences to discourage this misuse of the facilities. The Borough representative stated that reseeding of the barren spots was planned.

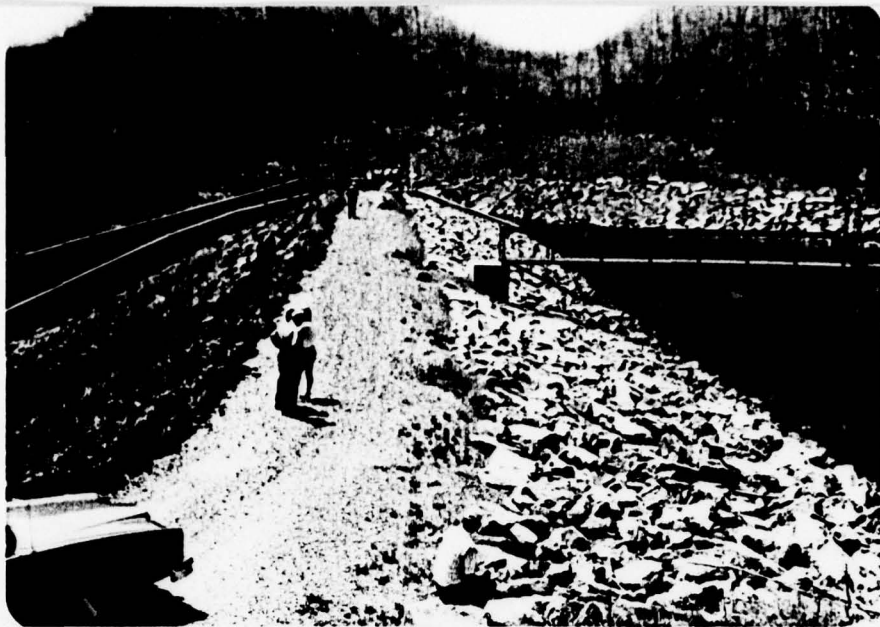
View of Dam.
Spillway in
background.

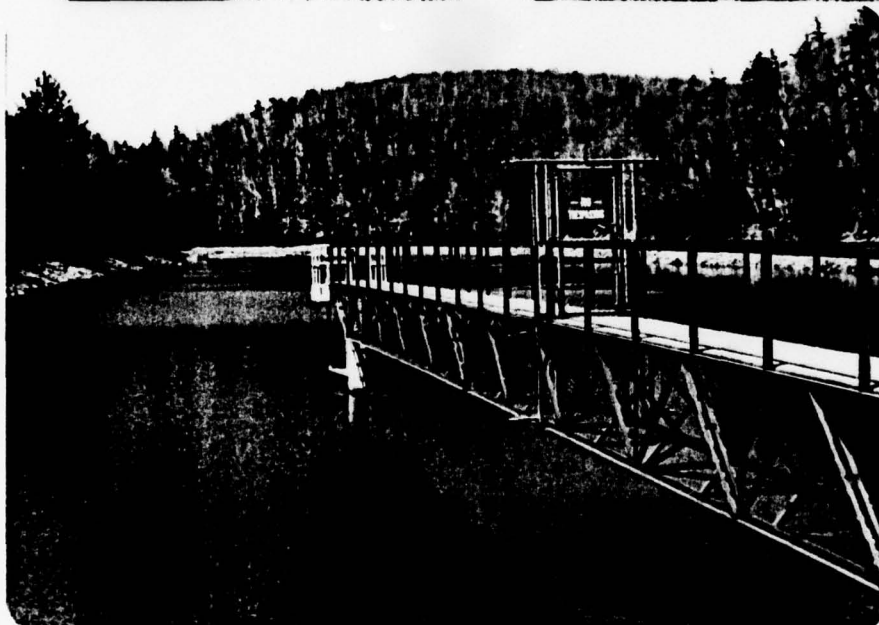
The intake tower is located near the upstream toe of the dam and is accessible with a footbridge from the crest of the dam. The bridge, tower and sluice gate operator stands were all in good condition.

Bridge to intake
Structure.

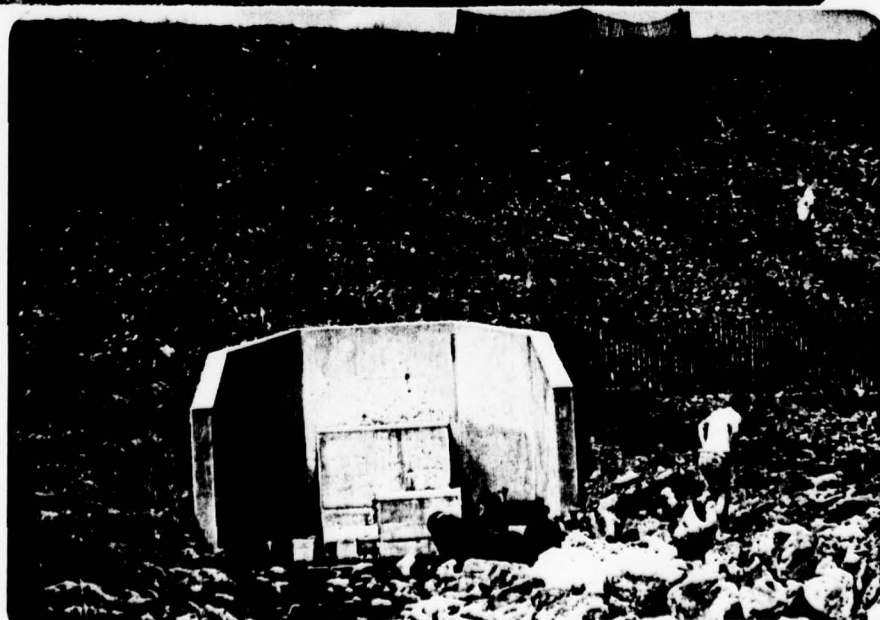
During the drought in 1975, it was decided by the owners to encase the end of the conduit with a concrete structure. This structure has a 12-inch pipe connected to the water supply line and a 24-inch x 24-inch opening which can be closed off with a steel plate (Refer to Appendix E, Plate E-I). When the upstream drawdown sluice gate is opened and this plate is installed, water can be taken out of the reservoir when the pool level falls below the lowest normal intake. Under this condition, the conduit is under pressure.

The downstream end of the outlet tunnel is fitted with a concrete-box type enclosure. The opening in the box is on the right side, is rectangular in cross section and measures 23 inches by 24 inches.

Conduit Outlet with
Concrete Enclosure

It is recommended that the owner submit engineering data to PennDER indicating the adequacy of the conduit as a pressure line, or remove the concrete structure at the end of the outlet conduit.

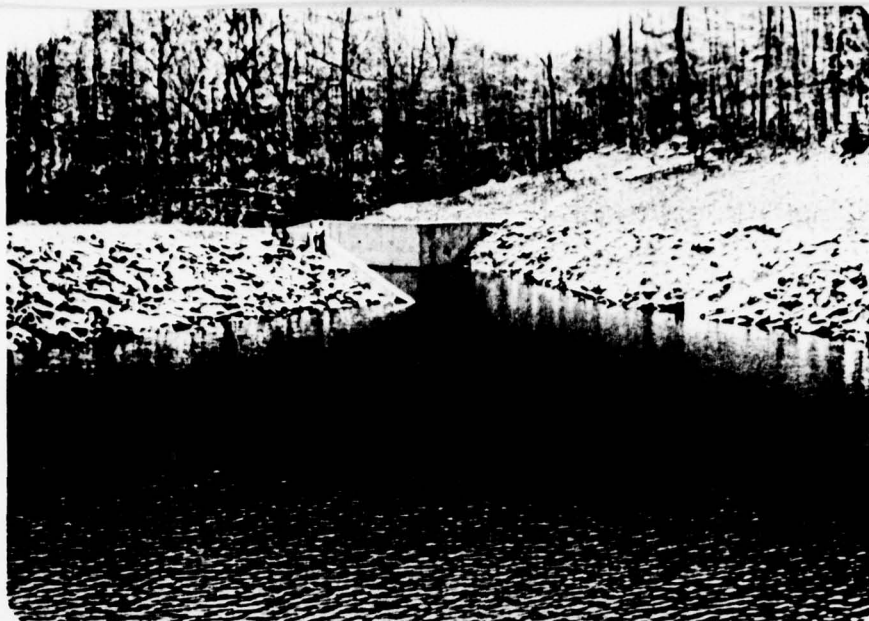
The spillway is located in the right abutment of the dam. The forebay is well protected with heavy riprap and the right forebay wall is butted far into the hillside. Although the approach width appears to be skewed awkwardly and relatively narrow, sufficient width and depth appears to be available during high water. The concrete of the ogee section was in good condition with only one small crack. The walls of the spillway chute and stilling basin are high and will certainly contain any flow over the spillway. All concrete was in good condition.

Forebay Area

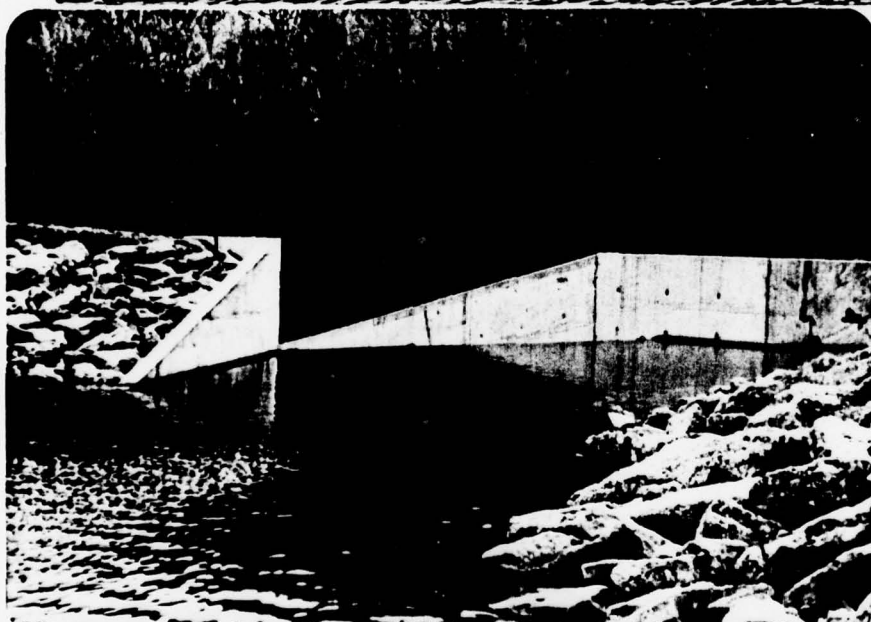
Detail forebay
Walls

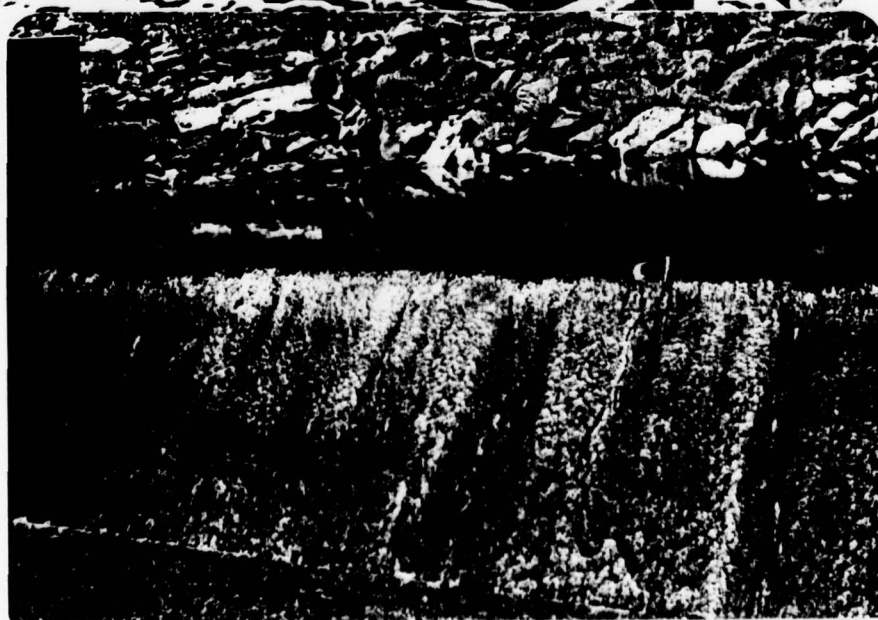
Spillway Ogee
Section

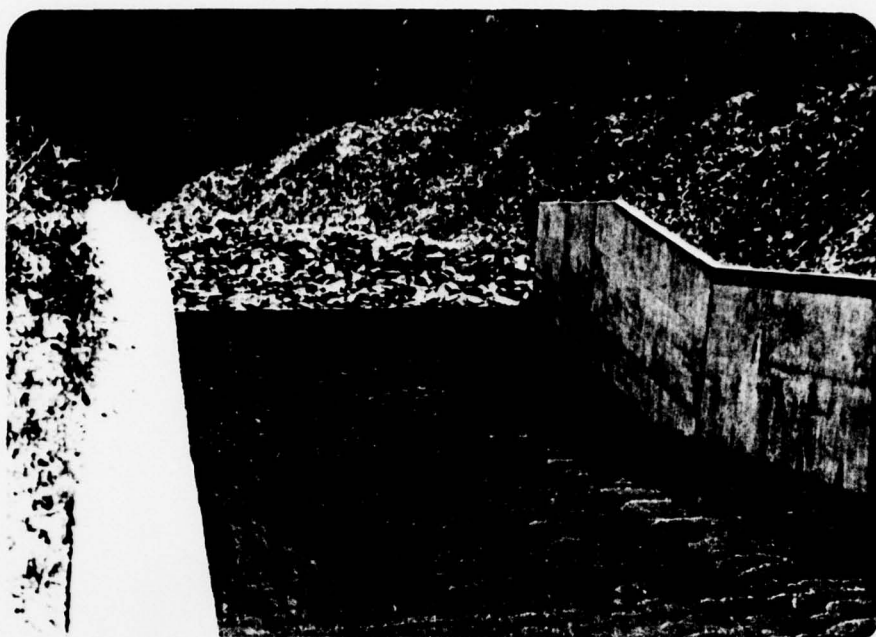
A wet area was located between the outlet structure and stilling basin. No flow of water was detected and it appears that only minor seepage is occurring at this point. An additional wet area was observed on the left hillside downstream of the stilling basin. It appears that this water is coming from the hillside and not from the embankment or dam abutment.

Stilling Basin & Downstream Channel
